# Long-Lasting Provisional Restoration Case

by Dr. Gary Radz

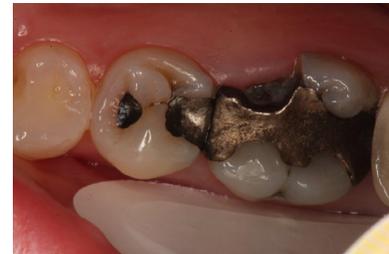
A 45-year-old female presented with a fractured mesial lingual cusp on tooth #19 (Figure 1). Two years previously the patient was treatment planned for a build up and crown on this tooth. Due to finances the patient had delayed treatment.

The cusp had fractured off a week ago. The tooth is now cold sensitive and the soft tissue that has overgrown the area is tender. Radiographically #19 shows no evidence of decay or apical pathology. But, #20 shows a small area of recurrent decay on the distal.

Figure 1: fractured mesial lingual cusp on tooth #19

The patient is shown the intraoral photographs and the radiographs. A treatment plan of a DO composite resin on #20 and a build up and all-ceramic crown on #19.

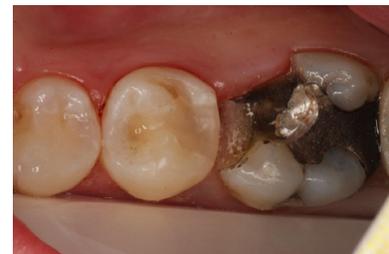
Figure 2: the restoration is taken to a final polish

A sectional matrix is placed on the distal of #20. Using a selective etch technique the enamel is etched for 15 seconds. A universal bonding agent (Ecosite Bond, DMG) is then placed in the preparation for 30 seconds, air thinned, and light cured for 10 seconds. The cavity preparation is completely filled with a bulk fill composite resin (Ecosite Bulk Fill, DMG), manipulated into place and light cured for 30 seconds. The matrix band is removed and the restoration is light cured for another 10 seconds. The occlusion is then adjusted and the restoration is taken to a final polish, as shown in Figure 2.

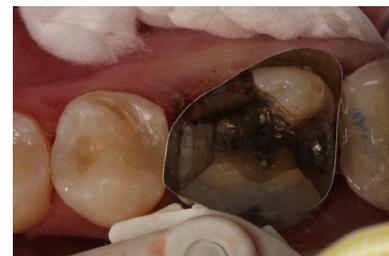
Figure 3: The preparation is isolated using a disposable 360 degree adjustable matrix

The restoration of the missing tooth structure can be quickly achieved using a dual-cure composite resin build up material (LuxaCore Z Dual, DMG). The preparation is isolated using a disposable 360 degree adjustable matrix (Figure 3).

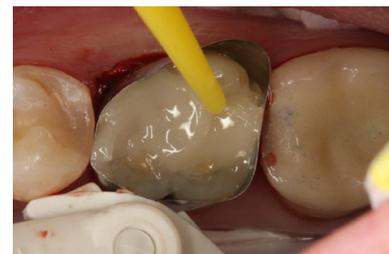
Figure 4: The dual cure composite resin is injected directly into the preparation/matrix

Using a selective etch technique the enamel of #19 is etched for 15 seconds, rinsed and lightly dried. Next a universal bonding agent (Ecosite Bond, DMG) is placed on the entire preparation for 30 seconds, air dried and light cured for 10 seconds. The dual-cure composite resin is injected directly (Figure 4) into the preparation/matrix until it is completely filled, and light cured for 30 seconds. The matrix is removed and the entire restoration is light cured again for 20 seconds and is now ready for the final preparation (Figure 5). The final preparation is completed with a series of chamfer diamond burs to create the margins and clearance required for a PFM crown. Using the diode laser the margins are trenched to control hemorrhage and expose the preparation margins in anticipation for the final impression (Figure 6).

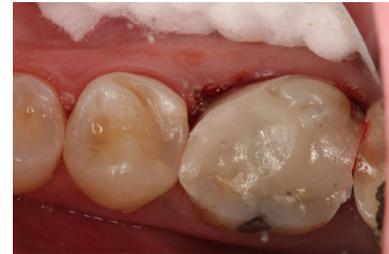
Figure 5: The matrix is removed and the entire restoration is light cured

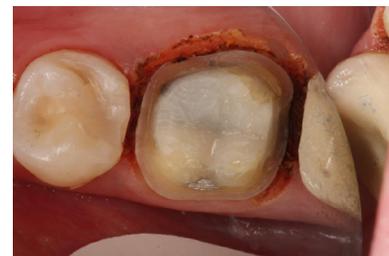
Figure 6: Using the diode laser the margins are trenched to control hemorrhage and expose the preparation margins

Using a diode laser to perform a gingivectomy on the lingual of #19 to remove the excess soft tissue that has overgrown the fracture margin. The extent of the fracture is now visible. The fracture terminates 4mm above the height of bone, so no hard tissue alteration is required. Using the 557 burr the rest of the amalgam present in #19 is removed. Upon removal of the amalgam there is recurrent decay is noted using a caries detector on the distal aspect of the tooth. A #4 round burr is used to remove the remaining decay. The prepared tooth is now missing a significant amount of tooth structure and needs to be replaced.

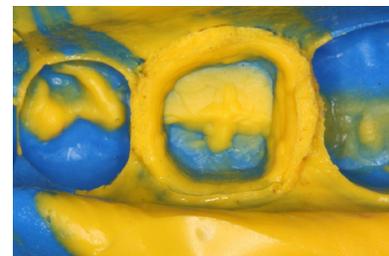
Figure 7: The final impression is taken using a fast setting PVS impression material

The final impression is taken using a fast setting PVS impression material (Honigum, DMG) (Figure 7). Lastly, the occlusal relationship is captured using a PVS bite registration material (O-Bite, DMG).
