# QUICK CASE: Carla Cohn, DMD

## Icon® Caries Infiltrant Smooth Surface Treatment

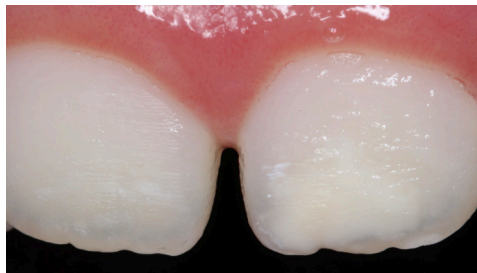
- ↗ 6 year old female, tooth #21
- ↗ Molar incisor hypomineralization

Before treatment

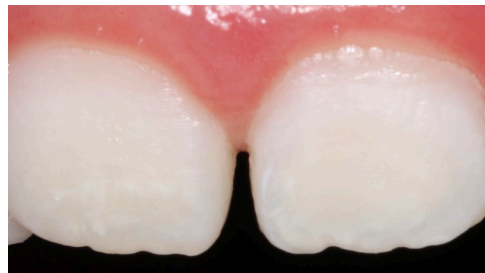
Immediately after treatment

- 1**
  - ↗ Pumiced
  - ↗ Abraded with coarse disc

- 2**
  - ↗ Etched according to manufacturer's instructions

- 3**
  - ↗ Allowed infiltrant to penetrate for 18 mins.
  - ↗ No light exposure prior to light cure
