A Semi-Permanent Restoration Option for Patients with Health or Financial Challenges

by Dr. Alan Pressman, DMD

CASE OVERVIEW

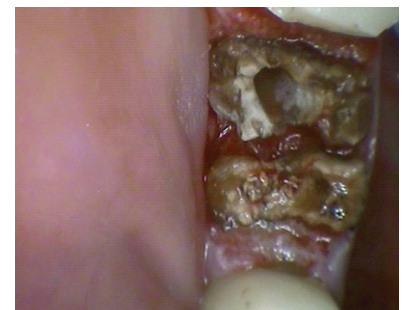
A 67-year-old female patient presented to our office with a loose tooth. Clinical examination revealed recurrent decay under a 30-year-old crown on tooth #30 as well as mobility of the crown (Figure 1). On removal of the crown, decay was noted throughout the pulpal floor of the tooth (Figure 2). Because the patient is on bisphosphonates, I ruled out extraction and an implant as a course of treatment. We took a periapical of the tooth to determine full decay and root length (Figure 3) and concluded that the root length was adequate.

Figure 2: Decay visible after crown removal

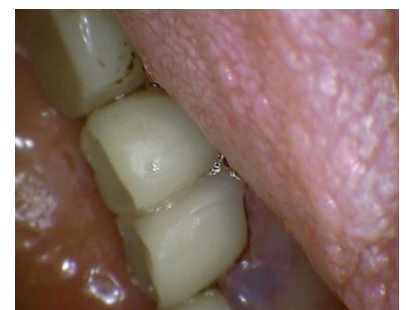
Figure 3: After cleaning tissue and removing caries

I came up with a plan to bi-cuspidize the molar and rebuild using 2 posts and LuxaCrown. I describe LuxaCrown to patients as a semi-permanent material. I took a VPS impression using a matrix material and temporary tray to fabricate the restoration. I anesthetized the area with a fast-onset anesthetic. Using a CO2 laser, I gently finished the sectioning the roots where the decay had started to penetrate. I also cleaned up the tissue around the roots and removed the remaining caries (Figure 3). The canals were prepared with a suitable reamer, rinsed with water and dried with a paper point. I cemented two glass fiber-reinforced composite posts (LuxaPost, DMG America) with a self-etch, self-adhesive resin cement. Using a dual-curing universal

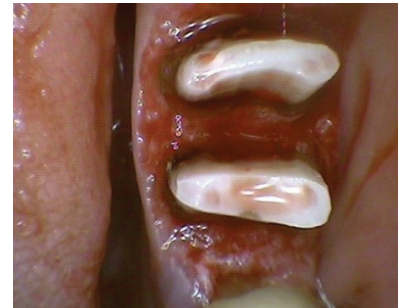
Figure 4: Rebuilt cores

adhesive and a core build-up material made with zirconia (LuxaCore Z Dual, DMG), we then rebuilt the cores (Figure 4). We were careful to prepare the roots with adequate ferrule on clean tooth structure. The trick to using a matrix impression is to remove a small amount of the impression material. It is always easier to start with excess material and then trim back than to add material in case of a deficit.

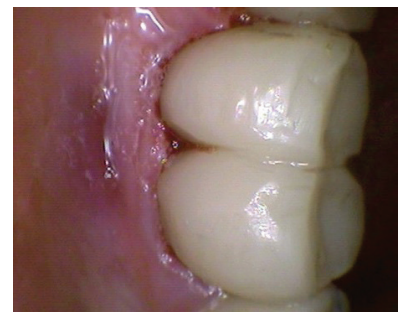
Figure 5: Final restoration

I injected a semi-permanent crown and bridge material (LuxaCrown, DMG) from the bottom of the impression and filled without raising the syringe to prevent voids. The crowns were shaped using a double-sided diamond disc and carbide finishing burrs. I then polished them using a polishing system. I tried to make the splinted crowns as cleansable as possible. When trimming the semi-permanent crown, it is denser and stronger than a methyl-methacrylate temp material. The final restoration (Figures 5 and 6), was cemented in with a self-adhesive resin cement. The patient was very pleased with the fit, aesthetics, cost and time required to place the restoration.

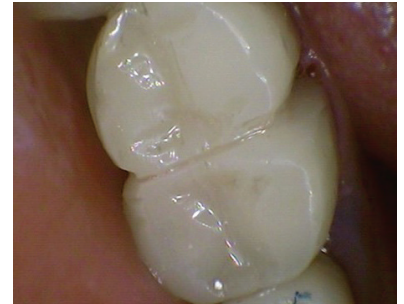
Figure 6: Final restoration, secondary view
