A New Semi-Permanent Crown & Bridge Material Bridges an Age-Old Gap

by Richard S. Bernstein, DDS - November 2019

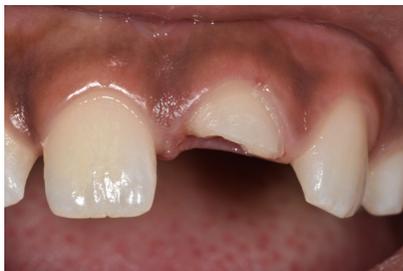
Figure 1: Fractured maxillary left central (mirror image of #8)

Based on the endodontic consultation, my first step was to perform a root canal treatment. An impression was created with a lab-fabricated, all-porcelain post/core using a leucite glass-ceramic (IPS Empress, Ivoclar Vivadent). I then created a build-up of #9 as a mirror image of #8 on the hard model.

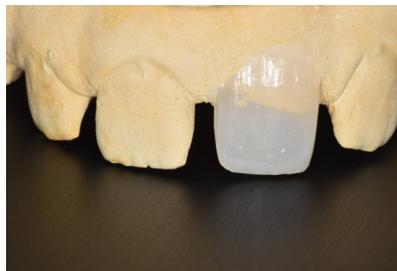
Figure 2: Ideal mock-up of left central incisor impression of mock-up

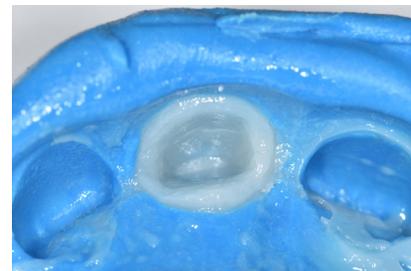
Figure 3: Using the poly vinyl impression of the mockup, the luxacrown restoration was fabricated

I then took a polyvinyl matrix (Honigum, DMG) of the mock-up, expressed a long-term crown and bridge material (LuxaCrown shade A1, DMG) into the impression, and placed it in the mouth over the dentition. After one minute, I removed, trimmed and polished the LuxaCrown restoration. Various burs (ET, Brasseler), polishing discs and rubber points were used to finish the restoration just as I would if it were a permanent composite restoration. The margins were finished, trimmed, smoothed and polished. Finally, a varnish (LuxaGlaze, DMG) was placed and light-cured. The LuxaCrown long-term crown was bonded over the tooth with a resin cement (Theracem, BISCO).

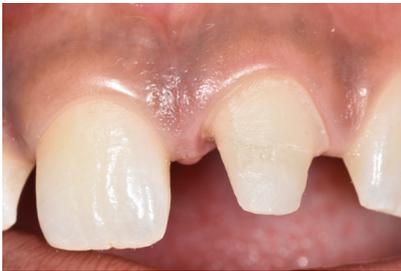
Figure 4: Prepped tooth after all-porcelain post/core was bonded

Next, I bonded the post/core into the root of #9 using a core build-up material (LuxaCore Z Dual, DMG), after which I prepped the existing tooth to the gingival level with a chamfer finish line.

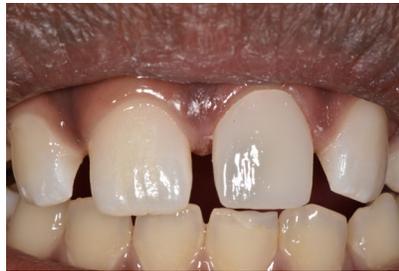
Figure 5: Semi-permanent crown bonded in place; margins finished, final polished and glazed

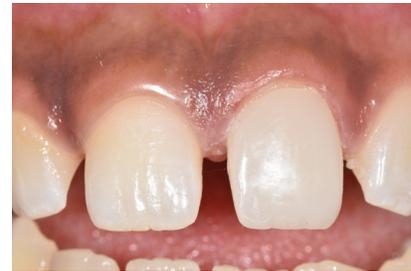
Figure 6: Crown at one-month follow-up

At the one-month follow-up, the patient was very pleased with the esthetics, durability and fit of the LuxaCrown long-term crown.
