Icon Smooth Surface Treatment of Incisors

Written by Dr. Shukan Kanuga | October 2020

Case Report

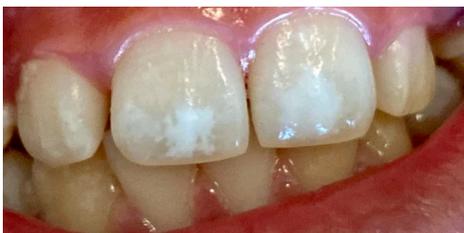
BEFORE

9 year 9-month-old ASA-1 female, Jade presents with mom for a routine 6 months recare visit. She had mentioned about the white spots on the front teeth bothering her at the initial appointment in late 2019. ICON Resin Infiltration was briefly introduced at that initial appointment. Mom was interested but needed time to consider it. At the most recent appointment, further discussion about the treatment done in greater detail and all questions answered. Explained to mom about the shortcomings for deeper lesions. Mom consented and scheduled an appointment for another day. Nitrous oxide oxygen anxiolysis was presented as an option as the patient was nervous on the day of the appointment, but she was very excited as well for the esthetic noninvasive treatment. We proceeded without Nitrous oxide oxygen. 4 rounds of Etch done and all manufacturing directions followed. Mom was pleased with the final outcome and patient was very happy as well. Will consider OTC bleaching products in the future when the patient is older to blend in the residual small developmental spots.

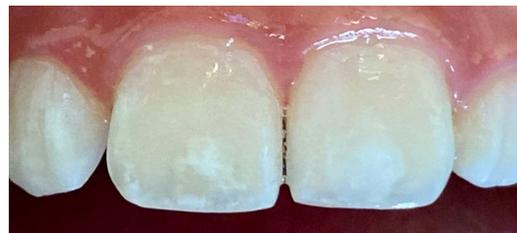
AFTER

While 100% of the spots were not eliminated, more rounds of etch were not carried out to avoid removing healthy enamel. It was a successful case nonetheless as seen in the pictures as the spots got much smaller and lighter. We would recommend ICON for WSLs post-Ortho treatment as well as developmental white spots on a case by case basis to improve esthetics and self-confidence in kids and teens in our practice. In this particular case, the patient could not stop smiling after treatment. ICON will remain an important treatment option in our toolbox as we also have Ortho in our practice, and we see several teenage patients.
