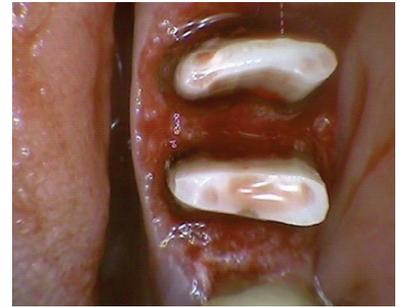
we then rebuilt the cores (Figure 4). We were careful to prepare the roots with adequate ferrule on clean tooth structure. The trick to using a matrix impression is to remove a small amount of the impression material. It is always easier to start with excess material and then trim back than to add material in case of a deficit.

Figure 4: Rebuilt cores

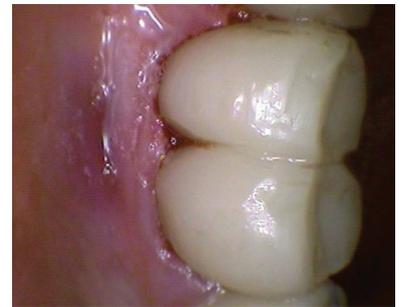
Figure 5: Final restoration

I injected a <sup>3</sup> V<sup>5</sup> Self<sup>+</sup> Y crown and bridge material (LuxaCrown, DMG) from the bottom of the impression and filled without raising the syringe to prevent voids. The crowns were shaped using a double-sided diamond disc and carbide finishing burrs. I then polished them using a polishing system. I tried to make the splinted crowns as cleansable as possible. When trimming the long-term crown, it is denser and stronger than a methyl-methacrylate temp material. The final restoration (Figures 5 and 6), was cemented in with a self-adhesive resin cement. The patient was very pleased with the fit, aesthetics, cost and time required to place the restoration.

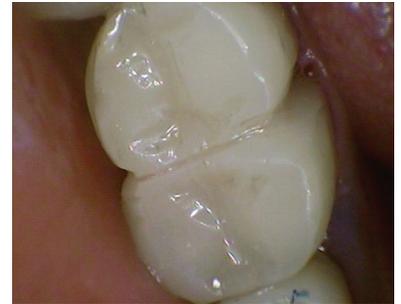
Figure 6: Final restoration, secondary view
