QUICK CASE: Carla Cohn, DMD

Icon® Caries Infiltrant Smooth Surface Treatment

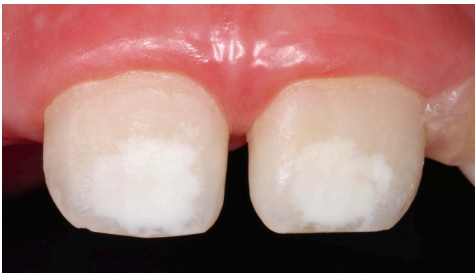
- ↗ 7 year old female, teeth #11, #21
- ↗ Molar incisor hypomineralization

Before treatment

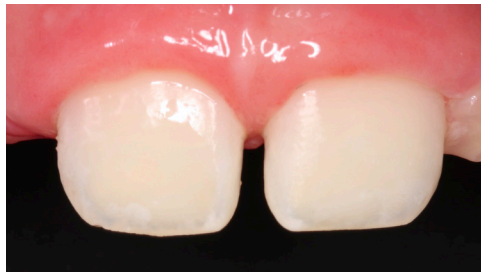
Immediately after treatment

- 1**
 - ↗ Pumiced
 - ↗ Abraded with high speed FG diamond (only use when necessary)

- 2**
 - ↗ Etched 3 times

- 3**
 - ↗ Allowed infiltrant to penetrate for 15 mins.
 - ↗ No light exposure prior to light cure

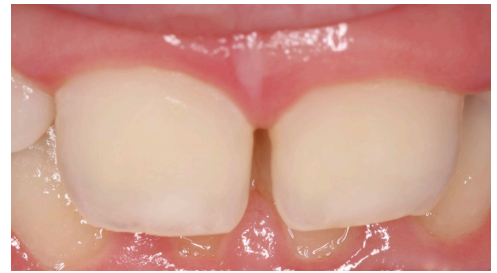
18 months after treatment
